Manhole Inspection Summary

Manhole # S31E__026MH

Insp Date: **8/8/08 8:38 AM**

Location Address: **130 n eutaw st**

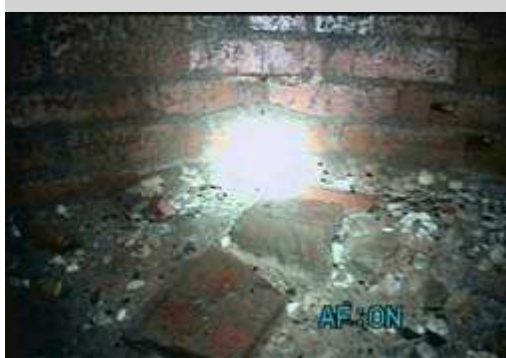
Defect 3

Condition: ☐ Sound ☐ Cracked ☐ Root Intrusion ☐ Deteriorated ☐ Leaks ☒ **Debris**

bench debris

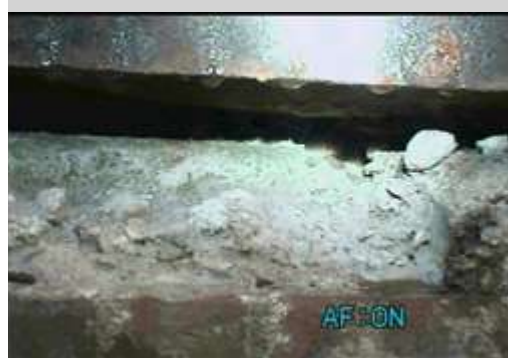
Defect 2

Chimney / Frame Adjustment ☒ Exists Material: **Brick and Concrete** ☐ Parged Height: **3** (in.)

Condition: ☐ Sound ☐ Cracked ☐ Root Intrusion ☒ **Loose Brick** ☒ **Deteriorated**

loose bricks, deteriorated

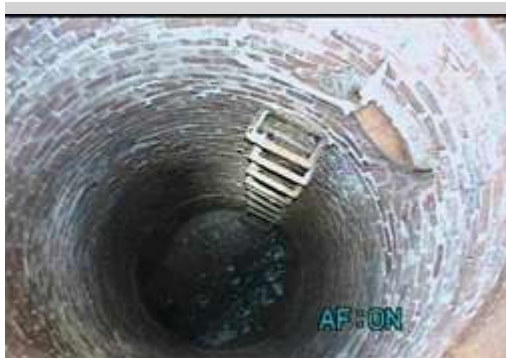
Defect 1

Steps Count: **13** Missing: **0** ☒ **Corroded**

steps

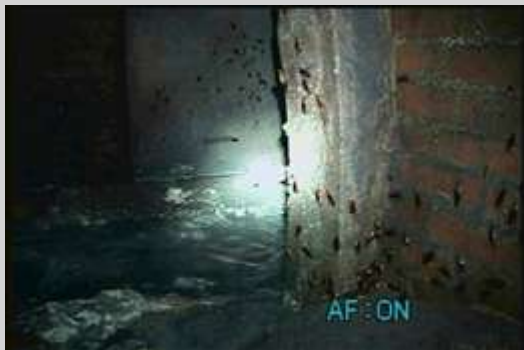
12 O'Clock Outflow

pipe is around corner & under ledge in a vault

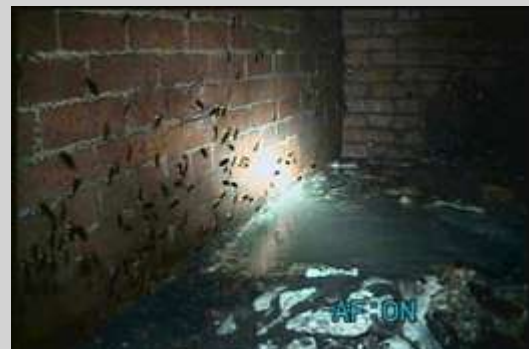
Drop In @ 5 O'Clock

pipe is under a ledge in a vault cant get better picture
